WoF news

VEHICLE CERTIFICATION UNIT

March 2007 Issue 10

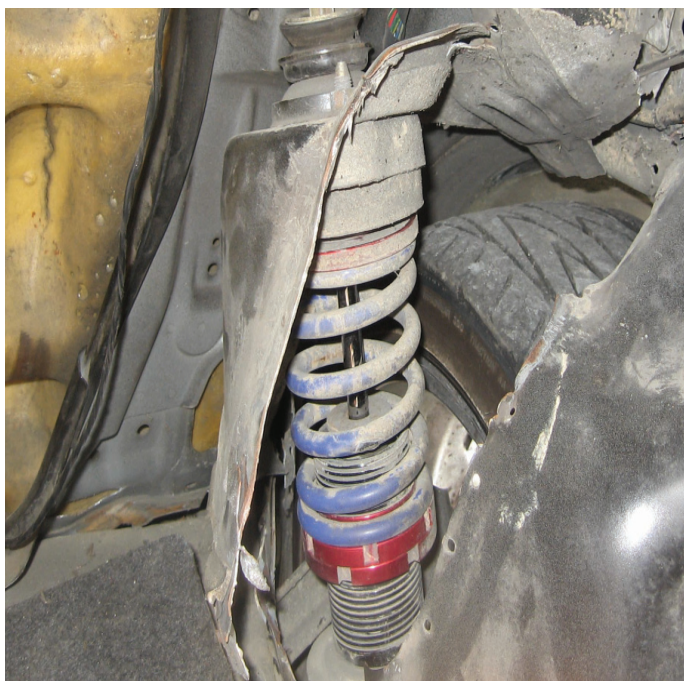
The picture below is from a 1994 Mitsubishi Lancer and shows how the RH rear suspension strut has broken through the housing structure. This is the result of removing all suspension travel, which caused a hammering of the structure and broke the spot welds and ripped the metal.

The issue of a WoF being given to this vehicle a few weeks before this photo was taken is being investigated.

Check out the bottom of the seat frame pulling away from the floor, right across to the other side.

Please take care when inspecting the boot area around struts. If you see that the suspension has been modified, you must also check for an LVV plate.
