## Have you missed this newsletter?

## WoF failure results for 2009

# New winter tyre requirements in force from 1 April 2010

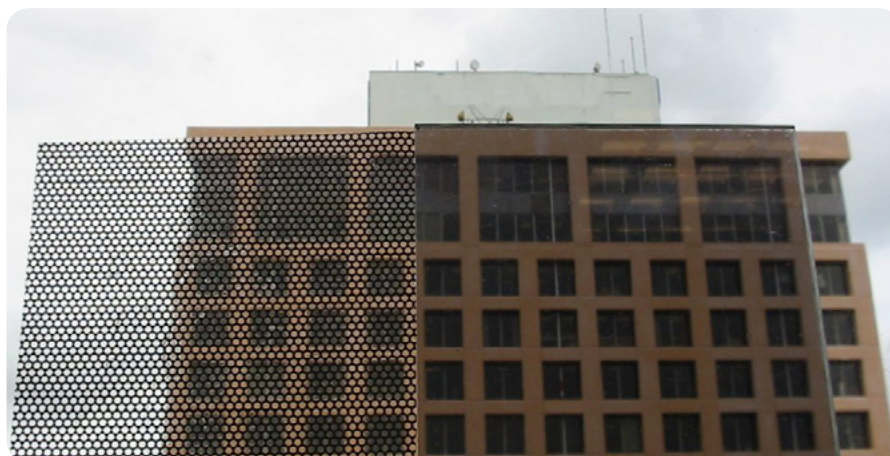
This is another reminder that perforated overlays fitted to rear windows of class MA vehicles is not allowed. These overlays are not transparent, but opaque with holes cut out. The 35% VLT requirement can only be applied to transparent overlays.

See Note 5 on *VIRM* page GV 5-1-9 and 5-1-10. The picture below (from *WoF News 8*) shows the difference in visibility through the overlay between perforated (left) and transparent (right). Visibility through the perforated overlay is even worse when viewed at an angle.

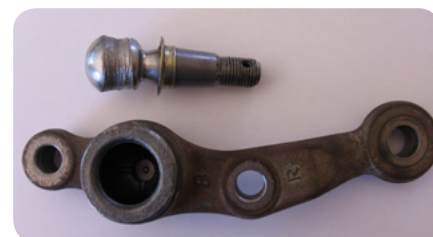
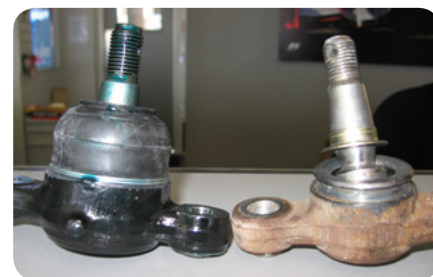
## Lower-front-ball-joint wear on late 1990's to early 2000's Toyota Altezzas

The joints wear about the ball and can become jammed in the housing before coming apart and leaving the vehicle stranded. This jamming of the joint does prevent an inspector from locating any play so it is advised that care be taken when inspecting these joints. If any play is detected, the operator should be advised to have it replaced.

The NZTA's Pat Towers has been made aware of almost a dozen incidences of these joints pulling apart whilst the vehicles were being driven, resulting in the vehicle's wheel pushing upwards from the bottom and the lower control arm and brake assembly taking the full brunt of hitting the tarmac.

You can also see the difference between the old joint and a replacement (both genuine) where the new joint is substantially larger than its predecessor.
