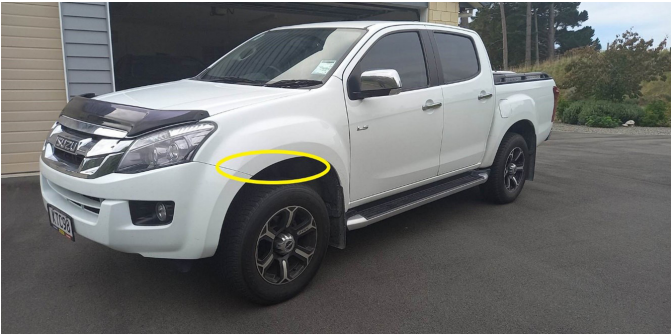
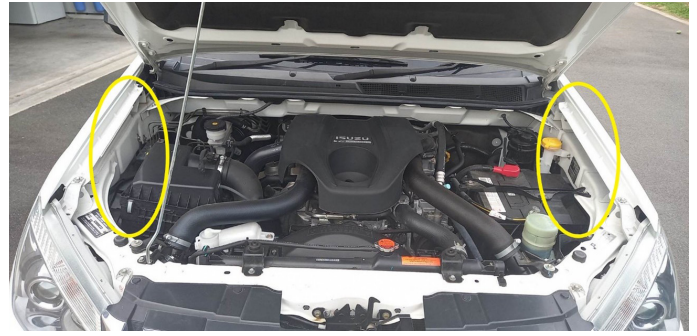
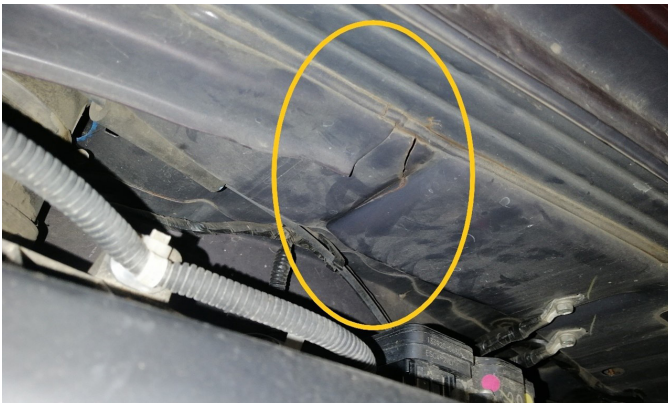
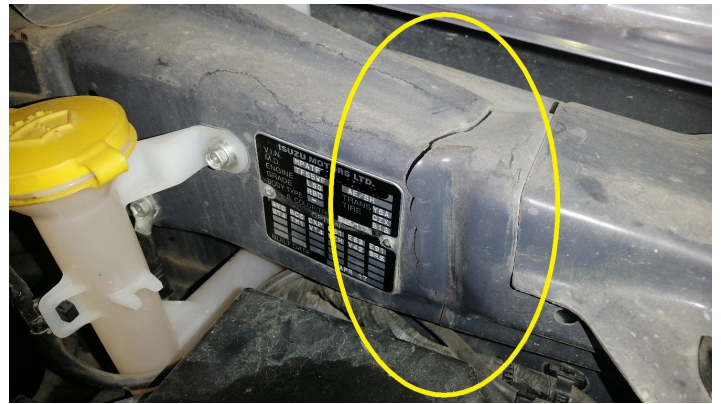
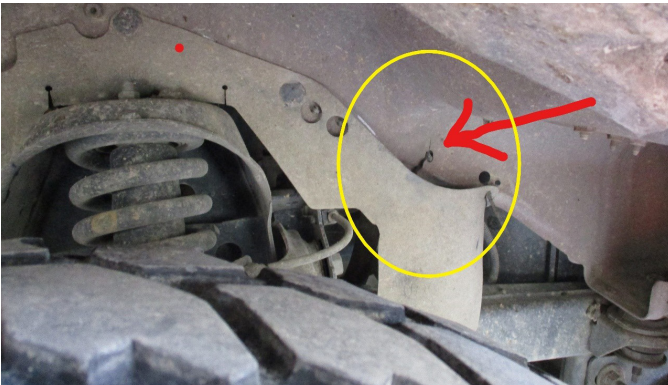
Isuzu D-Max cracking in engine bay

Some second-generation Isuzu D-Max vehicles have been developing serious cracking to the inner structural components of the engine bay and the structure behind the front wheels. This issue may be exacerbated by fitting heavy-duty bull bars. Vehicle inspectors should look for damage to both sides of the engine bay structure in models from 2011 and 2019.

In some instances, there's cracking through the wheel arch.

The cracking in the photos is clearly reasons for rejection as per the VIRM 3-1 Structure – Reasons for rejection 1 (a, b, and c) and figure 3-1-2:

1. The structure of the vehicle (shaded areas of [Figure 3-1-2](#)) has visible:
 - a) deformation from the original shape that has affected the vehicle's structural integrity (Note 1) (Note 3) (Note 9) ([Figure 3-1-4](#)), or
 - b) cracking, or
 - c) fracture

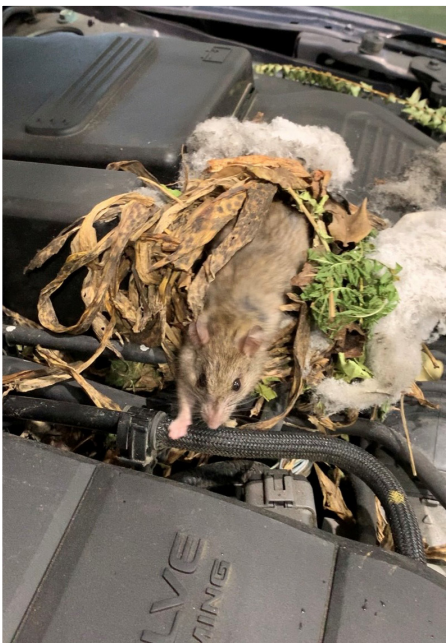
It soon became clear that Bill had misheard the customer when they said rattle under the bonnet

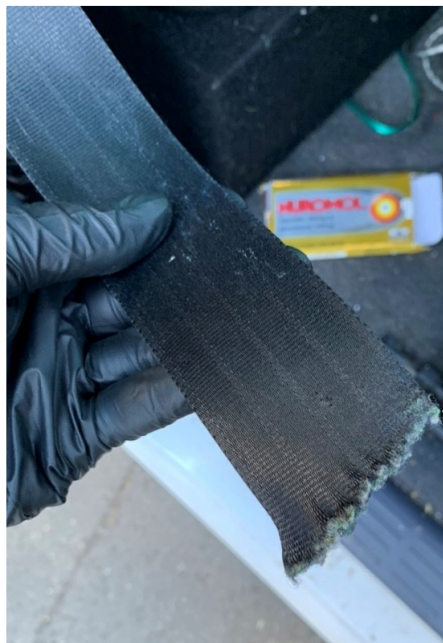
Tom hoped that his second attempt at DIY seatbelt re-webbing would be considerably more successful than his first

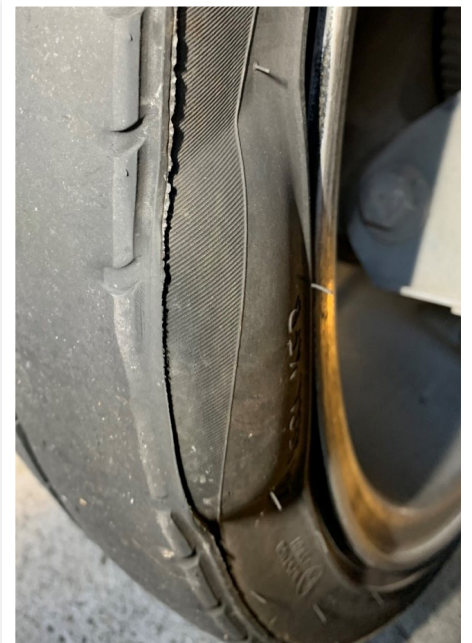
Rick had seen tyres with rim protection before, but never to this extent
