VIRM: IN-SERVICE CERTIFICATION AMENDMENT 1 JUNE 2019

List of changes and preview pages (WoF and CoF)

In this amendment

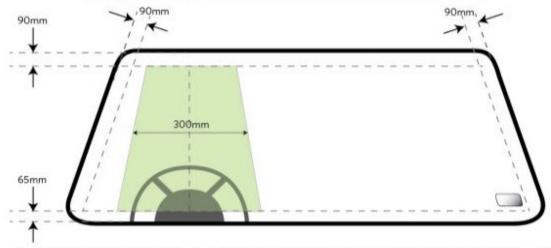
To be measured from the inside of the vehicle from the point where the glass is visible (ie after any seals)

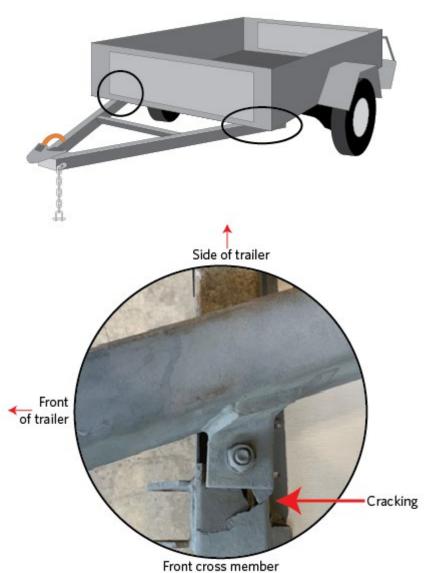
Figure 3-1-3. Drawbar attachment to trailer

Special attention should be given to the point or points where the drawbar attaches to the body of the trailer. This is often the first point of structural failure on trailers.

- 1. The structure of the vehicle (shaded areas of Figure 3-1-2) has visible:
 - a) deformation from the original shape that has affected the vehicle's structural integrity (Note 2), or
 - b) cracking (Note 3) (Figure 3-1-3), or
 - c) fracture, or
 - d) corrosion damage (Note 1) that is individually larger than 50mm in diameter (Figure 3-1-1), or
 - e) any corrosion that the inspector considers has caused weakening of the load-bearing structure, or
 - f) poor repairs (Note 1) that have not returned the structure to within a safe tolerance of when it was manufactured (Note 2), such as:
 - i. filler has been used in an attempt to conceal corrosion damage or deformation of a component, or
 - ii. a high strength steel component has been heated.

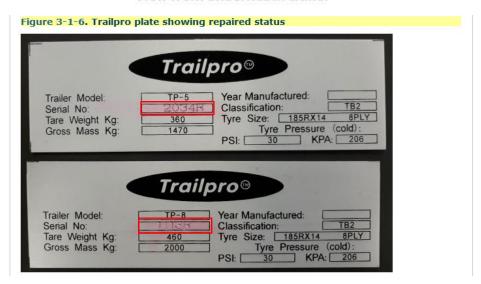
Repaired trailers are identified by an 'R' after the serial number (Figure 3-1-6).

View from underneath trailer

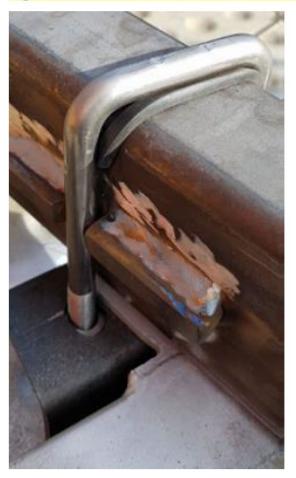
Figure 3-1-7. New front mount of the repaired Trailpro 8x4 and 8x5 trailers

6. The trailer is an unrepaired Trailpro 8x4 Tradesman (model number TP5) or a Trailpro 8x5 Tandem (model number TP8), with a bolt-through drawbar attachment (these trailers are subject to safety recall) (Note 4). See Figure 3-1-5 for advice on identifying these trailers. See Figure 3-1-6 and Figure 3-1-7 for advice on identifying repaired Trailpro trailers.

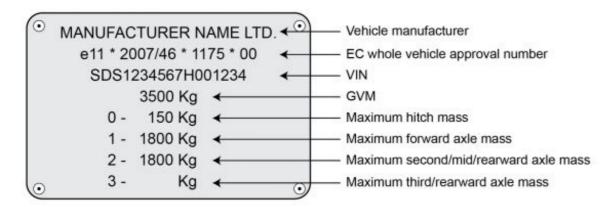
Identifying the EC whole vehicle approval plate

A trailer that has European whole vehicle type approval will have brakes compliant with UN/ECE Regulation 13. These trailers are identified by a plate very similar to the following:

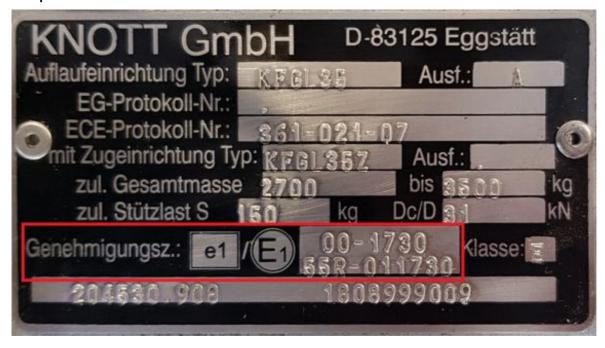
Compliant hitch

• A compliant hitch will be fitted with a plate like the one above that indicates it is compliant to Reg. 55 as per the red highlighted section in the image.

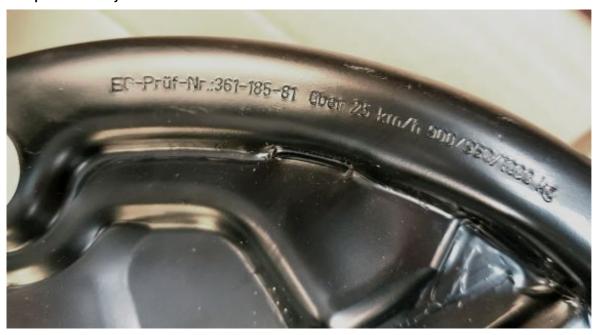
Compliant brake system

• A compliant brake system will require 4 brakes acting across 2 axles (one per wheel). The back of each brake drum will have a test number marking like that shown above.
