TOW COUPLING AND BOLT IN TOW-EYE SECURITY

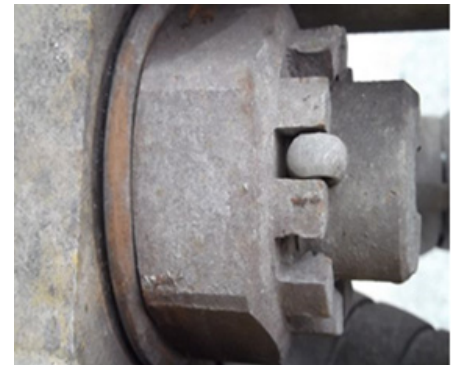
Pictures of this failure mode are provided on the right. Note in the top image that there is clearance between the retaining nut, washer and tow-eye boss. The retaining nut to washer interface shows cupping of the washer and signs of rust inclusion. As mentioned, these are signs that the tow-eye is not fully secure in its boss. The retaining nut is still locked in the position that it was originally tensioned to by use of a split pin. That suggests that checking the nut and split interface is not a reliable indicator of coupling security.

In the top image the bolt in tow-eye has come loose without the retaining nut backing off which suggests that the retaining nut and tow-eye shank threads have worn significantly. Attempting to retention those worn threads would be impractical and potentially inviting later failure.

Picture showing signs of unserviceable tow-eye.

When inspecting either the mounting nut on the tow coupling or the bolt in tow eye, ensure full and complete security of these items. Any looseness, witness marks or rust signs on the nut or washer, or that the washer is showing signs of "cupping" indicates that the coupling is loose would immediately be cause for rejection and replacement.

The seemingly obvious repair (as with other bolted fixtures that come loose) would be to remove the split pin and re-tension the retaining nut. On less critical parts and components that might be an option, however, in the case of bolt in tow couplings that practice is unacceptable as **just tightening the assembly is not adequate to provide continued safety.**

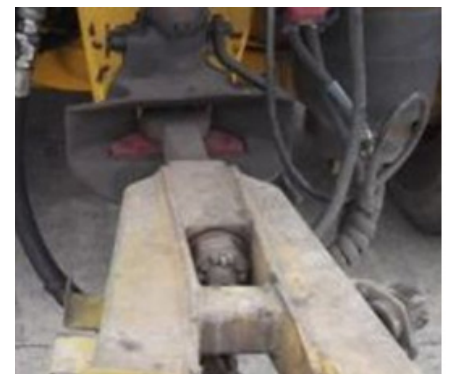
Fairly typical example of fitment into a drawbar.

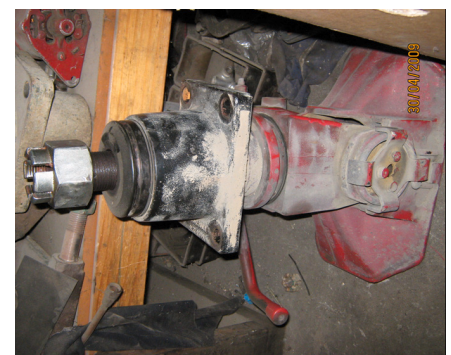
Generally, truck-mounted tow couplings are bolted onto the truck drawbeam through a mounting flange. The tow coupling is secured by a single large securing nut which is torqued to manufacturer's specification. The nut is then locked using a split pin.

Picture showing the securing nut on a typical pin type coupling fitted to a drawbeam.
