VIRM: IN-SERVICE CERTIFICATION AMENDMENT

December 2019 List of changes and preview pages (WoF only)

IN THIS AMENDMENT

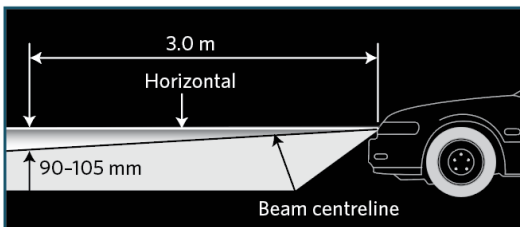
Symmetric dipped beam

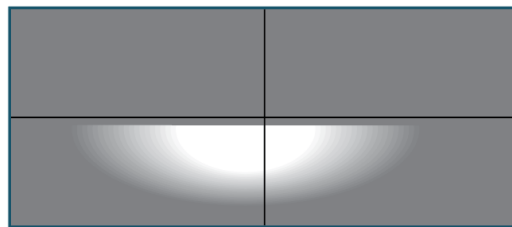
Modern symmetric dipped beam headlamp pattern on light board

Headlamp type	Distance from ground to centre of light source	Dip rate of beam centre: lower and upper limits		
			Percent (%)	mm/3 m	Degrees (°)
EITHER	Any headlamp dipped beam	N/A	That specified by the vehicle or headlamp manufacturer		
OR	Headlamp with an older style symmetric dipped-beam pattern (see Figure 4-1-2)	N/A	3.0–3.5	90–105	1.7–2.0
OR	Headlamp with a modern symmetric or asymmetric dipped-beam pattern and distance from ground to centre of light source (see Figure 4-1-2)	less than 0.8 m	1.0–1.5	30–45	0.57–0.85
		0.8–1.2 m	1.0–2.0	30–60	0.57–1.15
		more than 1.2 m	2.0–2.5	60–75	1.15–1.43

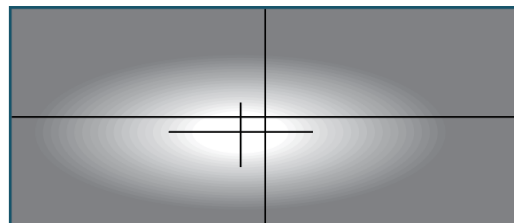
Older-style symmetric dipped beam headlamp pattern on light board

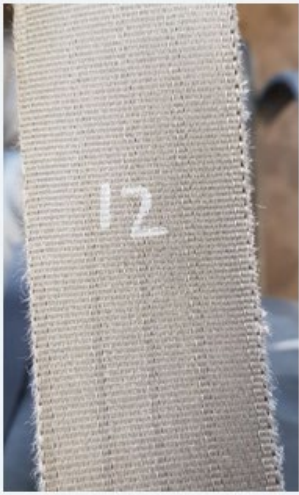
Figure 7-5-7. Examples for seatbelt webbing damage guidance

<p>Light edge fluff: very little damage to outer weave</p>

Note: If marginal, pass if the belt is still in good condition other than the marginal damage. Advise owner that the seatbelt is worn and recommend a replacement.

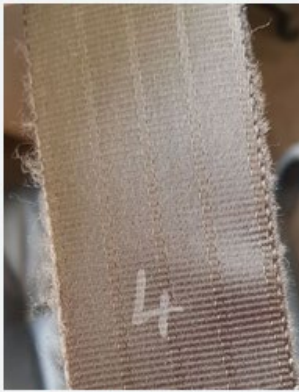
<p>Moderate edge fluff: some damage to outer weave</p>

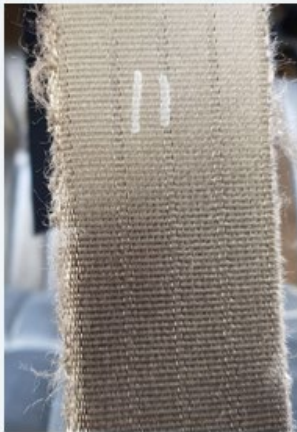
<p>Heavy edge fluffing/fraying or pulled 'tufts' of thread: outer weave heavily compromised</p>

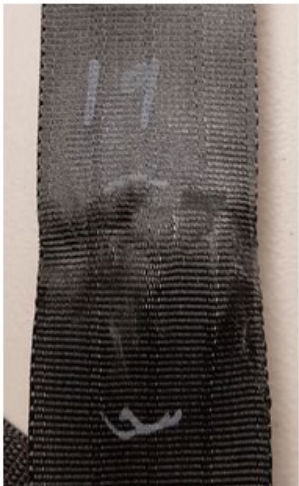
<p>Deformation in webbing with no cut threads or significant pulls</p>

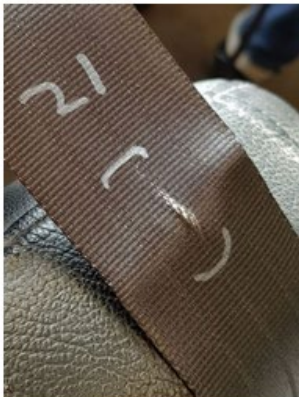
<p>Significant pull in webbing, no cut threads. Pull may start to disappear if webbing is worked</p>

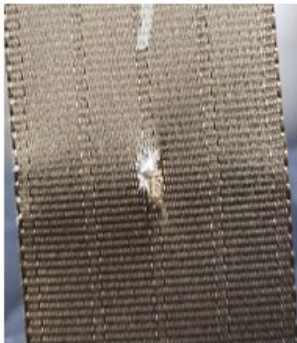
<p>Cut threads/hole</p>

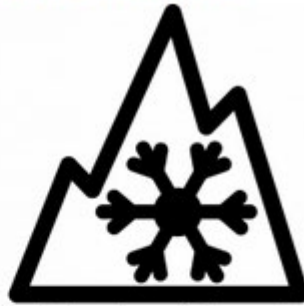
Figure 10-1-3. How to identify a winter tyre

Mountain and snowflake symbol

Note: For WoF purposes, a tyre is considered to be a winter tyre only if it has a winter tyre tread. Indicators of this are a studless marking and/or mountain/snowflake symbol (information from the manufacturer stating the intended use of the tyre can be taken into consideration when making a decision).

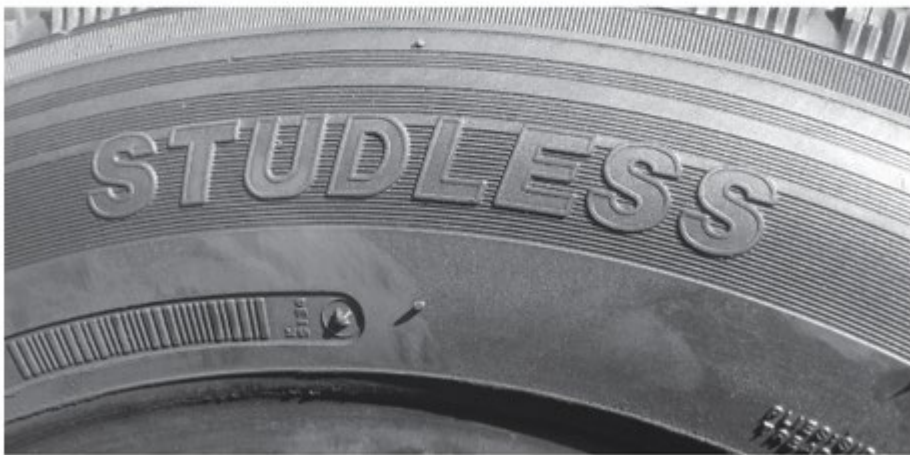
Example of 'Studless' on a tyre sidewall
