# VIRM: Border inspection of used imported vehicles amendment

1 October 2022 amendment preview

## Technical bulletin 4: Acid wash process on used imports

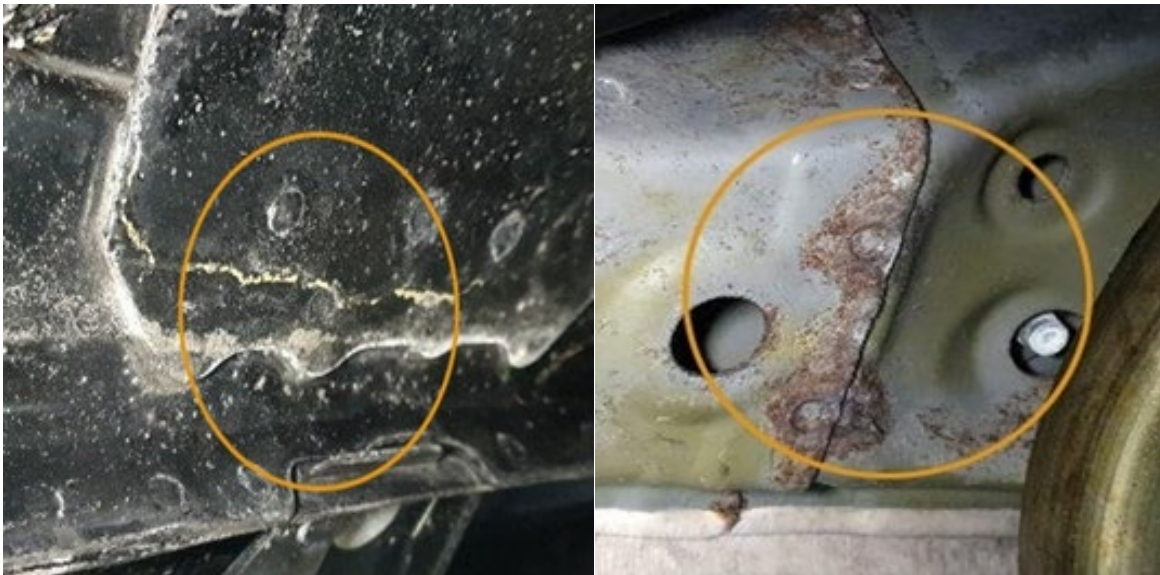
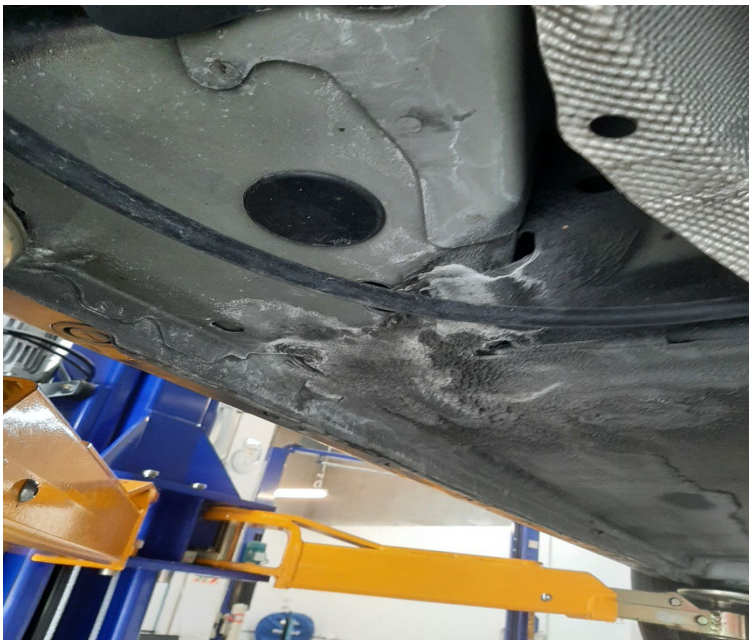
The process involves the use of a chemical mix containing an acid base liquid, phosphoric acid is commonly used, to remove corrosion and treat the metal area. The following photos show examples of visible signs of acid wash repair.

Visible signs of an acid wash repair include:

- The area has been cleaned and a clear topcoat, or no topcoat applied
- A white residue is noticeable in joints, seams, or coming through underseal/topcoats

- Corrosion is still visibly active in an area that has been treated

An area of metal that has not been acid washed correctly will continue to degrade within a short time and can be detrimental to the vehicle structure.

When visible signs of acid wash repair as described above are observed by an inspector at an entry compliance inspection the vehicle must be failed and referred to a Repair Certifier for assessment.

The threshold for requiring repair certification instructs 'A vehicle must be referred to a specialist repair certifier if signs of repair, rust prevention, acid wash or under-sealing to any part of the vehicle structure are evident'. The repair certifier will assess the repair and decide if it requires remedial work and a *Light vehicle repair record of certification* (LT308) issued, or if the repair is acceptable a *No repair certification required declaration – light vehicle* (LT307) issued.
