Are you a learner or restricted motorcycle rider?

New road user charges (RUC) system coming into effect on 1 August 2012

Shock absorbers - misting vs excessive leakage

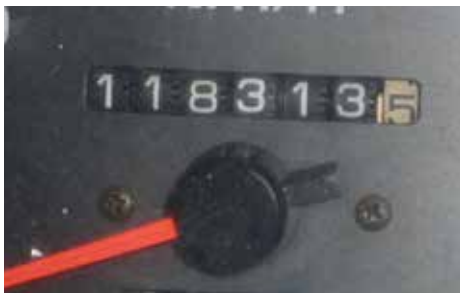
- Accidentally transposing digits, eg recording 19,000km instead of 10,900km.
- Recording the decimal digit as km, eg 109,007km instead of 10,900.7km (record as 10,900km, never record the decimal digit). Many vehicles don't have a decimal digit, but where there is one, it is usually easily identified, eg the "5" in the photo above.

The new system will verify RUC payments against odometer readings recorded at WoF inspections. If an odometer reading is higher than the odometer up to which RUC has been paid, the vehicle owner may be sent an assessment invoice. To avoid invoicing vehicle owners incorrectly, it is important that vehicle inspectors record the odometer accurately both on the checksheet and the inspection system.

The VIRM already requires vehicle inspectors to record vehicle information, including odometers, accurately. Here are a couple of common errors to be aware of and avoid:

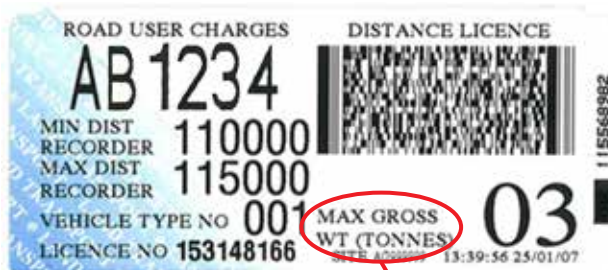
RUC label issued until 31 July 2012

Old and new RUC labels are the same except for the circled area

If you would like to provide an additional service to your customers, you may consider checking the vehicle's odometer against the vehicle's RUC label, see below, usually placed on the windscreen near the vehicle licence label.

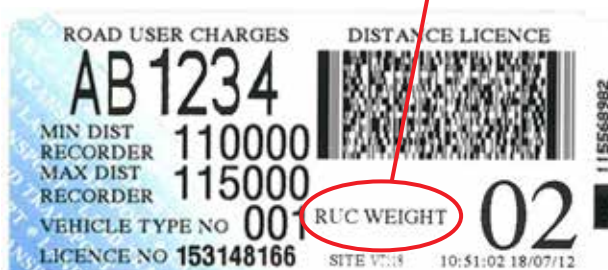
Example of RUC label issued from 1 August 2012

NZTA has developed a leaflet that can be handed to the vehicle operator if you find that the vehicle's odometer exceeds the "maximum distance recorder" on the RUC label. NZTA will shortly be sending out these leaflets to all WoF agents, and if you wish to provide this extra service, you may order further leaflets through Wickliffe free of charge if you order with your WoF books.

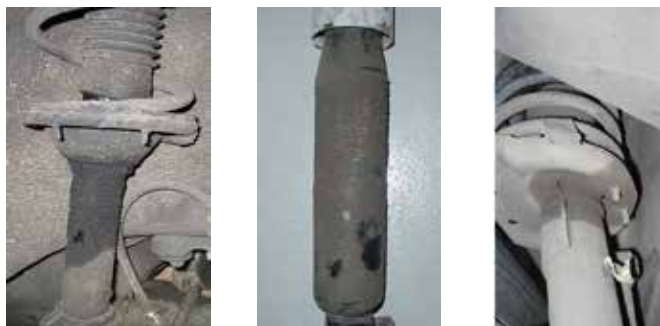
Misting is normal on shock absorbers and must pass for WoF/CoF.

By design, the piston rod carries a film of oil through the rod seal to lubricate the seal lips, thereby reducing friction / wear at the seal contact area, and prolonging seal life. Misting occurs when the hot piston rod is drawn out of the shock body and the microscopic film of hot oil on the rod turns to vapour. This vapour, or mist, condenses when it reaches the cooler outside air, and forms a film on the outside of the shock body. The film will attract road dust and debris, and will often coat the entire body of the shock.

Examples of misting shock absorbers (PASS):

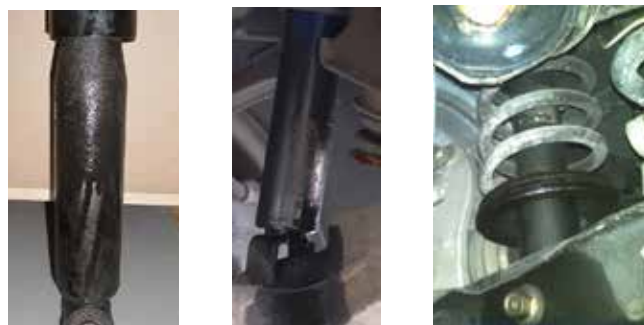
Rod seals may leak as a result of extreme wear, contamination, or defect. A leaking shock will show clear signs of oil leaking in streams from the upper seal down the shock body and may drip from the shock.

Such leakage is considered to be excessive and must be failed for WoF/CoF.

Examples of excessively leaking shock absorbers (FAIL):

NOTE: Some minor streaking of oil may appear on a new shock body during initial stroking. This is the result of the seal "setting" and purging any oil (from assembly) from the seal. This is not to be mistaken as a failure, as it is temporary and totals only a few millilitres of oil.
